## St Devenick's Bridge

also known as  
**The Shakkin' Briggie**  
and  
**Morison's Bridge**

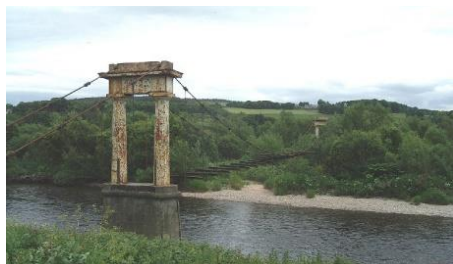
*The bridge today. Image by Peter Ward*

It became redundant after the southern approaches were swept away in the 1970s due to the changed course of the River Dee and the bridge no longer spans the whole river. The bridge has been derelict since 1984 when its timber decking was removed for safety reasons. The listed status of the bridge was changed from Category A to B in 2016.

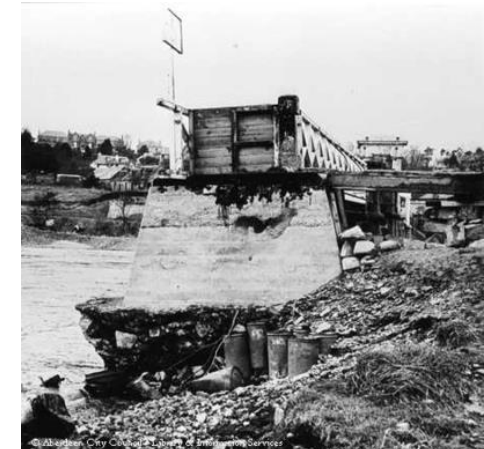
*Southern end of bridge after flooding. Courtesy Aberdeen City Council - Silver Vault*

The south side now ends the river and the southern approach span has been swept away Even if a new extension to the south bank were made it would only lead to edge of the golf course and there is no proper river path. To be used as a footbridge would require the decking to be raised by one metre to meet current regulations. Relocation and restoration would a multi-million-pound project and Historic Environment Scotland has indicated it is not keen on either relocation or raising the bridge.
